Manhole Inspection Summary

Manhole # S43SS_021MH

Insp Date: **2/22/07 10:15 AM**

Location Address: **1701 GORSUCH AVE**

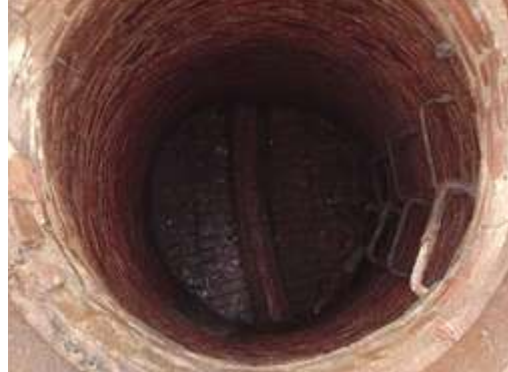
Top View

Corroded and missing steps. Evidence of surcharge - Bench debris.

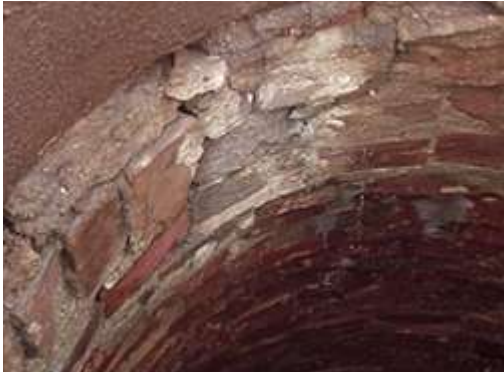
Defect

Frame leaks. Adjustment deterioration, loose brick and infiltration. Corbel infiltration.

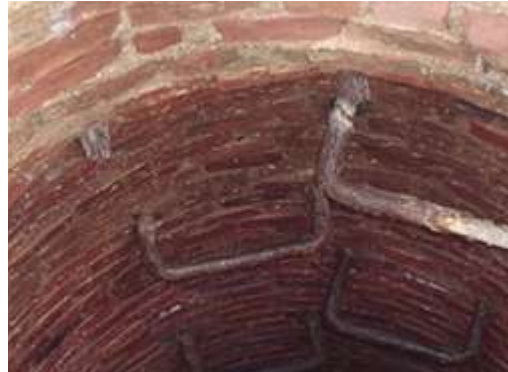
Defect

Corbel and Barrel infiltration.

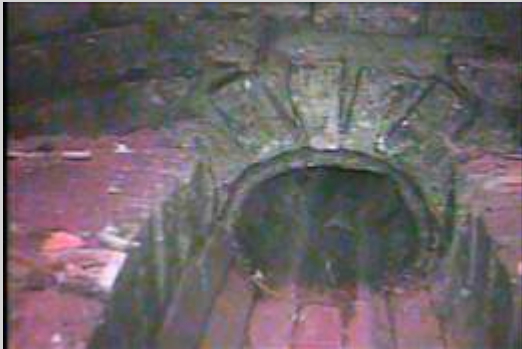
8 in. Circular Gravity Sewer Pipe Out @ 12 O'Clock

Infiltration: **Evidence** Pipe Seal Cond: **Unknown**

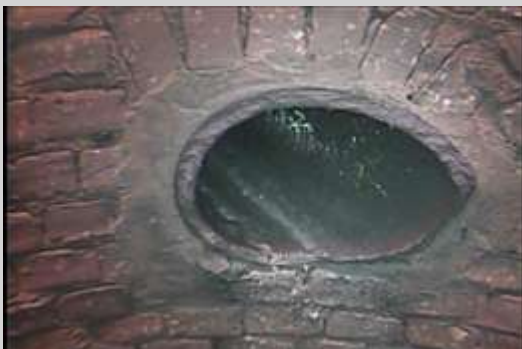
8 in. Circular Gravity Sewer Pipe In @ 5 O'Clock

Infiltration: **Evidence** Pipe Seal Cond: **Unknown**

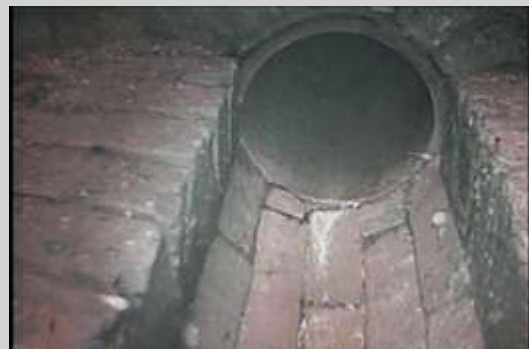
Drop In @ 5 O'Clock

Drop: **Outside** Rod and Bar

Drop Condition: **Open**
